Damage to dykes and levees in the Netherlands is extensive and increases with muskrat (*Ondatra zibethicus*) density

Abstract: The muskrat (*Ondatra zibethicus*) is an invasive species in the Netherlands. Its burrowing habits are alleged to threaten the integrity of the extensive water control infrastructure, posing a public safety hazard in this densely populated, low-lying country. A national control program currently traps and kills tens of thousands of muskrats each year. The costs (annually about € 35M) as well as concerns raised by animal welfare groups have raised questions about whether the control program could be improved, and even whether it is necessary at all. To better quantify the extent of putative damage, 2634 km of dykes, levees and banks were inspected annually (2013-2016) for 'major', and 220 km for 'minor' damage. The study was co-organised with a large-scale experiment (reported elsewhere) manipulating muskrat control effort in 117 randomly-selected 5x5 km squares on the national reference grid. We estimated the mean density of major damage at 0.50 ± 0.05 s.e. and that of minor damage at 17.6 ± 3.8 s.e. per kilometer of bank/levee. For both major and minor da

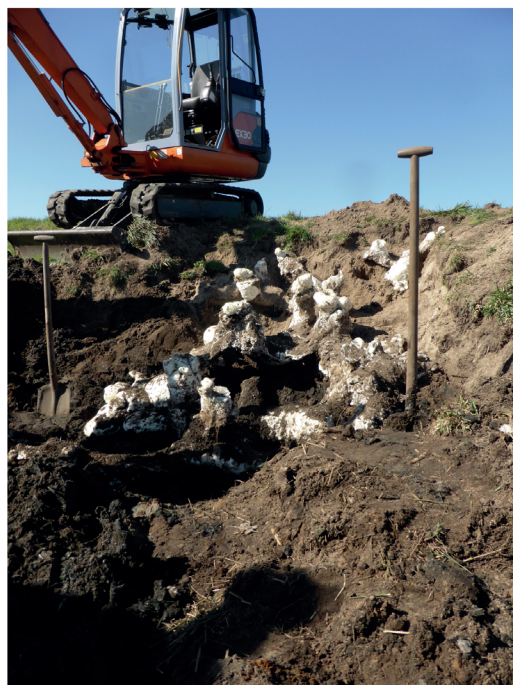
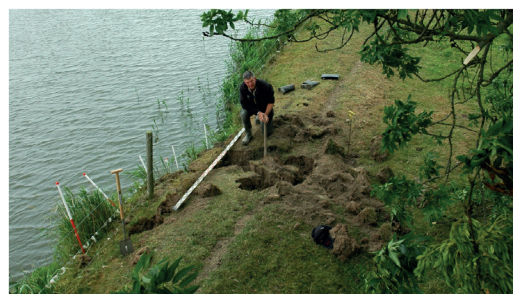
Figure 1. Typical muskrat burrows. Above, left: projections of three typical forms. Adapted from: COW 1984. Above, right: burrow excavated from a bank, after filling with styrofoam. Photo courtesy: M. Akkermans, STOWA. Below, left: cross section. From: COW 1984. Below, right: excavated burrow in a levee. Photo: H. van Hemert.

The entrance is usually submerged, presumably to reduce detection by predators. The outline and dimensions of typical burrows are presented in figure 1. Based on measures of five complete burrow systems (made by injecting liquid styrofoam and excavating the cast), burrow systems measure 2-6 m in width, extend 1.5-6 m into banks with nest chambers of 50 cm diameter, and entrances of 15-25 cm diameter (Akkermans 2014). The muskrats dig throughout the whole year as existing burrows are expanded to accommo-

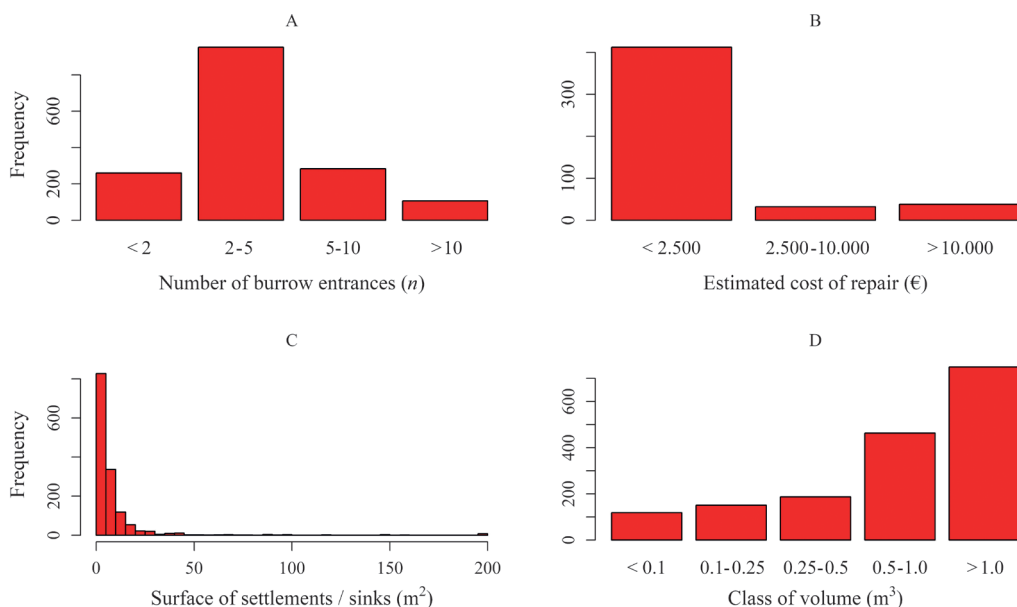
Figure 3. Histograms of the size of the major damages recorded. Panel A: number of entrances; Panel B: estimated costs of repair; Panel C: surface area of settlements and sinks; Panel D: estimated volume of soil displaced.

A summary description of major damage is provided in figure 3. The majority of major damages are characterised by multiple entrances (figure 3A), and had a repair cost less than € 2500 (figure 3B). The area of depressions or slumps associated with burrowing was in the majority of cases less than 10 m², but was occasionally estimated at 50 m² or even larger (figure 3C), while the volume of excavated soil was smaller than 1 m³ in 58% of the cases (figure 3D).

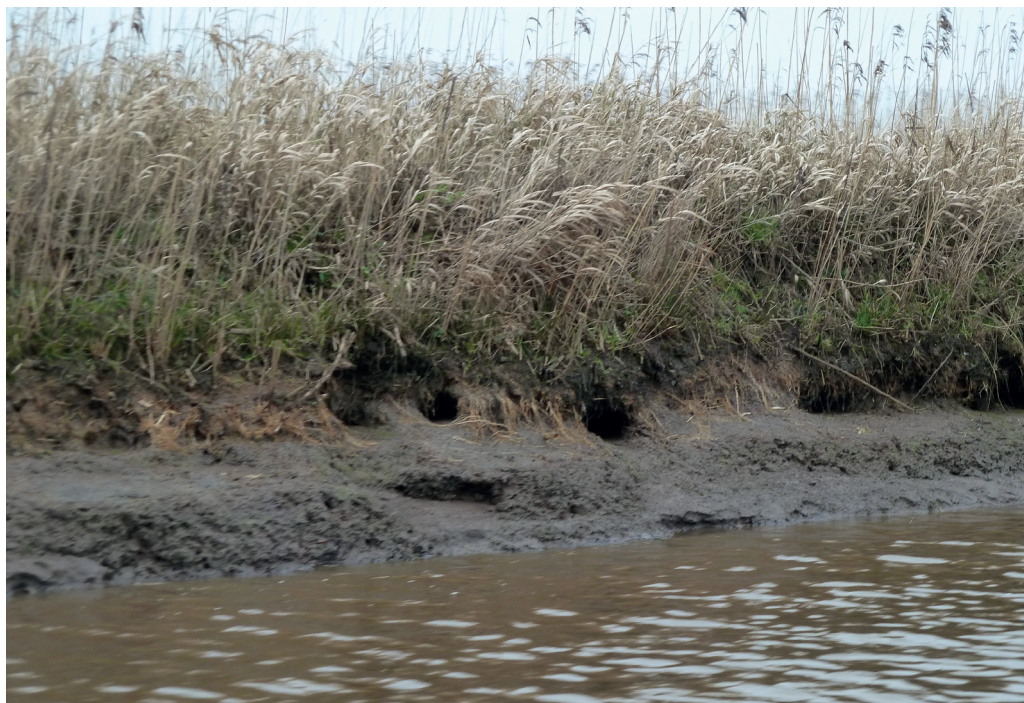
Figure 6. Outer slope of the levee along the Veendiep canal, during a drawdown of the water level to facilitate inspection. Several burrow entrances can be seen. March 2012. *Photo: M. Rothengatter.*
